Pump Action Assembly Note

October 15, 2005

Model: Escalade Pump Action Shotgun

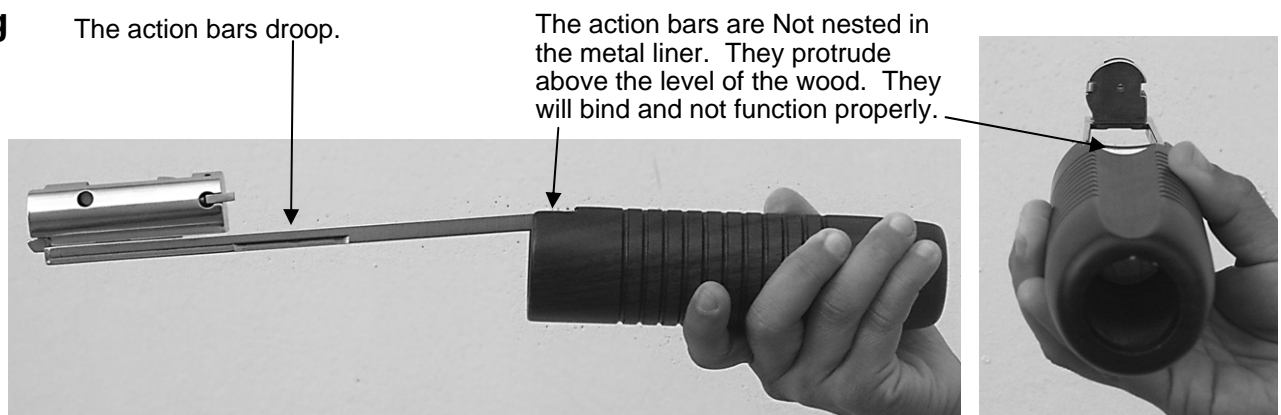
Wrong

Symptom: Action binds and will Not function properly.

Cause: When assembling the forend to the action, the action bars are incorrectly connected to the forend. The action bars probably are Not fully nested into the inner metal sleeve of the forend.

Solution: Assemble the action bars correctly as detailed here.
